Multiple-Purpose Project
Marmaton River, Kansas

Historical and Architectural Field Survey of a Portion of Fort Scott Lake Project, Bourbon County, Kansas

Contract No. DACW41-82-C-0169

Cultural Resources Report 83-8

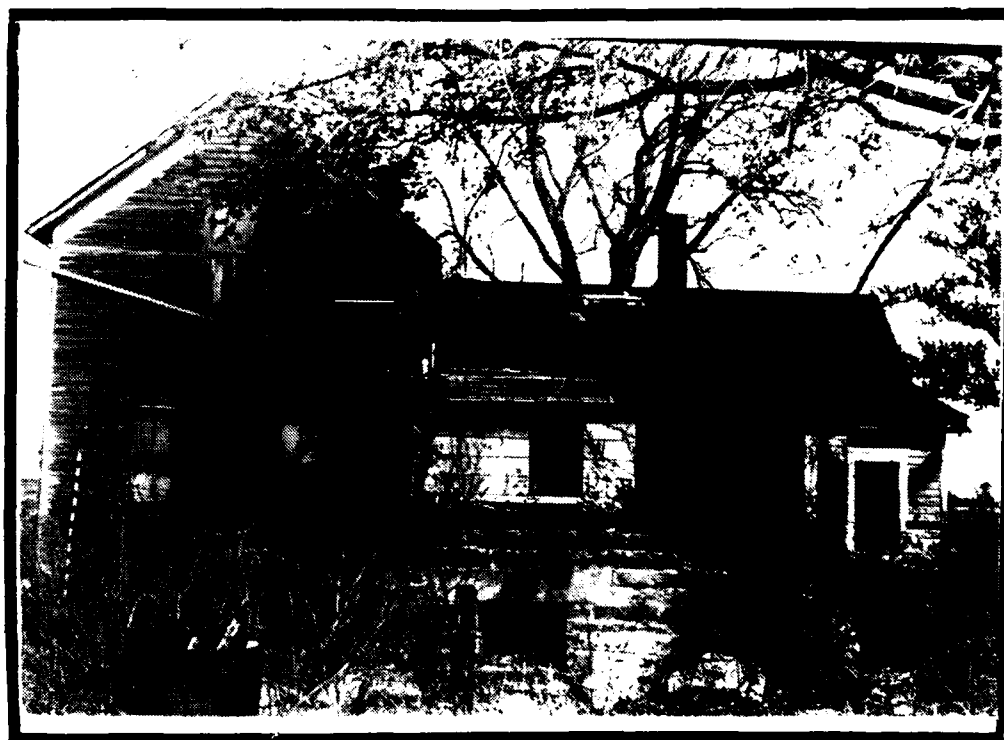
Figure 11. South elevation of FNI looking north. Root cellar in foreground, with the original one and one-half story house with an addition on the right.

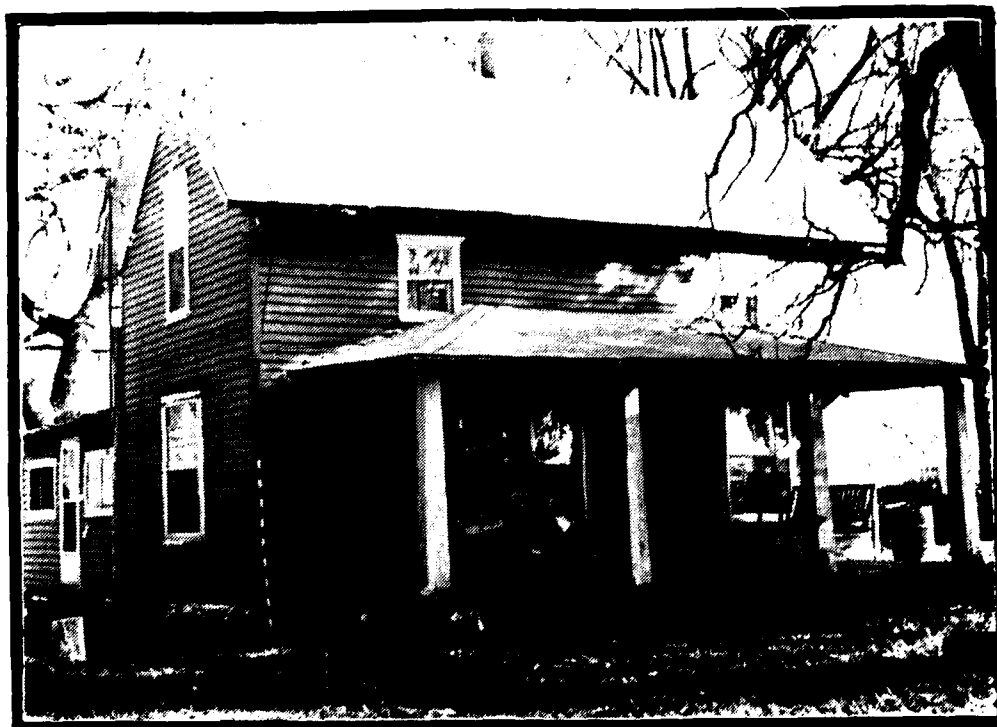
Figure 12. West elevation of FN3 looking southeast. Two-story hall and parlor house with full front porch.

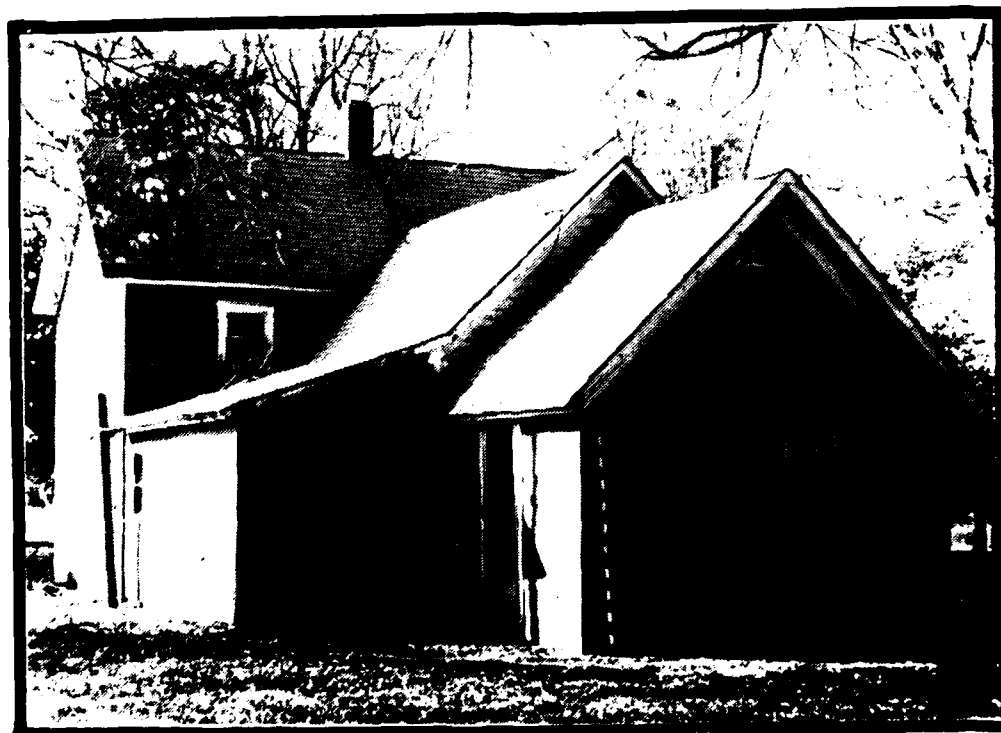
Figure 13. East elevation of house at FN3 looking northwest. Stair-stepped roof line shows progression of additions.

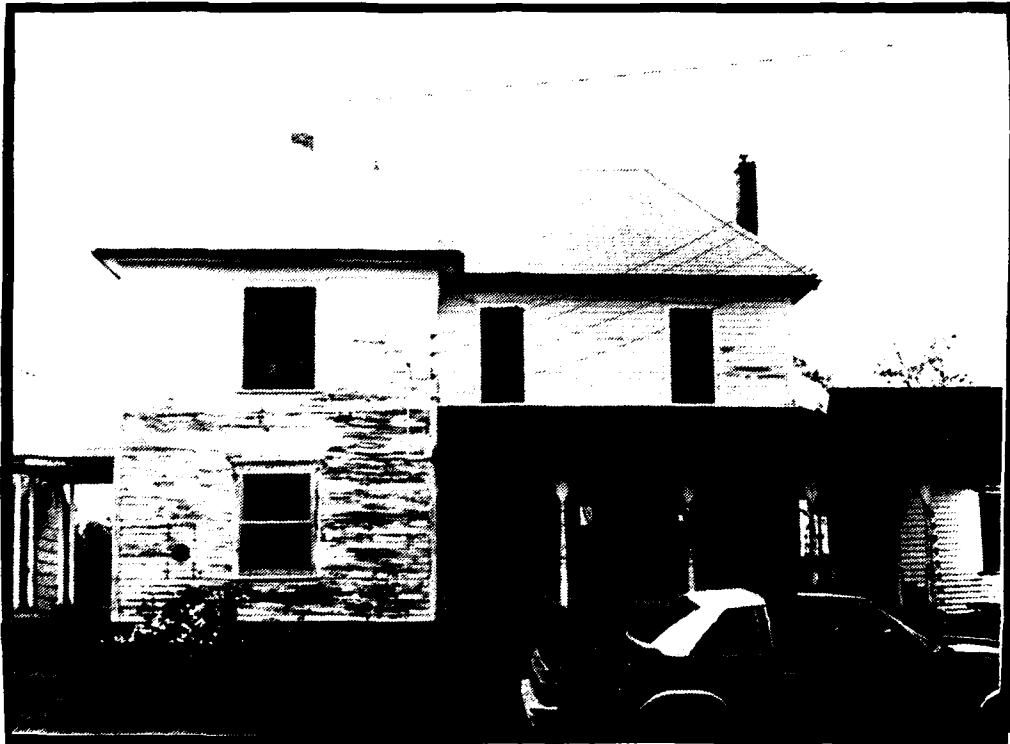
Figure 16. North elevation of house at FN5 looking south. Two-story T-house with a veranda porch and bunkhouse (on right).

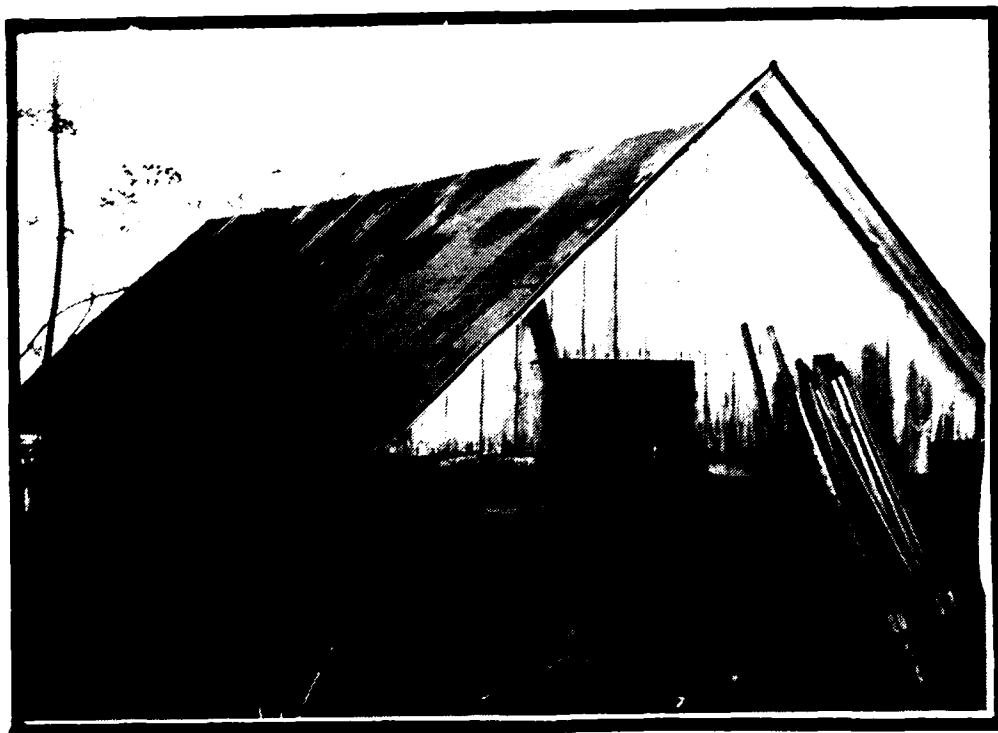
Figure 18. East elevation of log building at FN6 looking northwest. Log building with vertical board siding in the gable end.

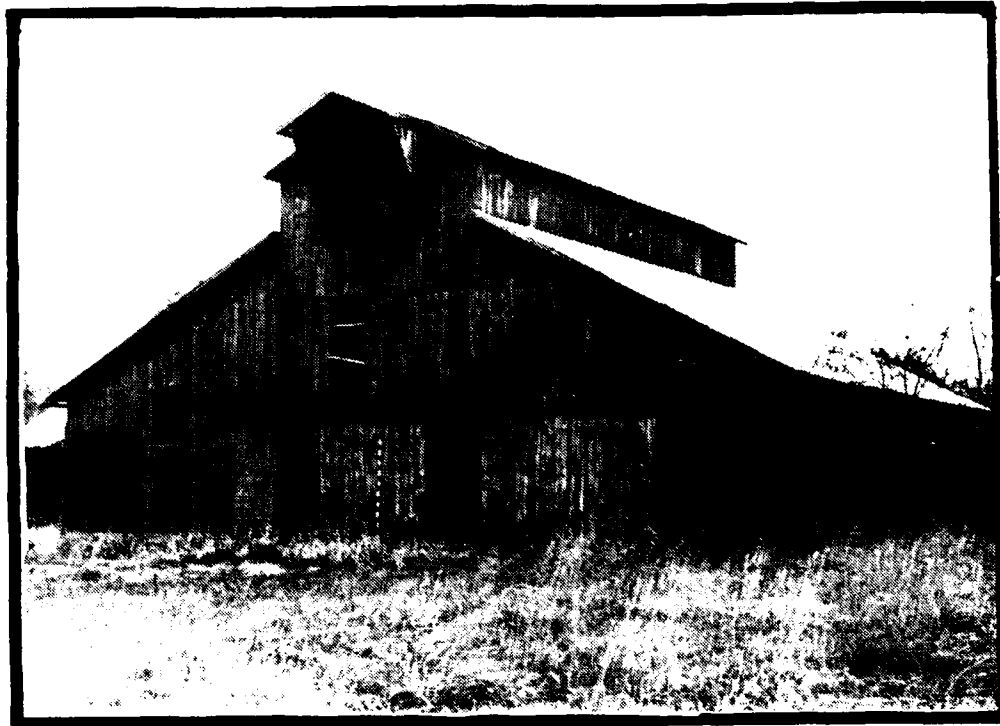
Figure 19. East elevation of barn at FN8 looking southwest. Monitor barn with an enclosed square-shaped hay hood.

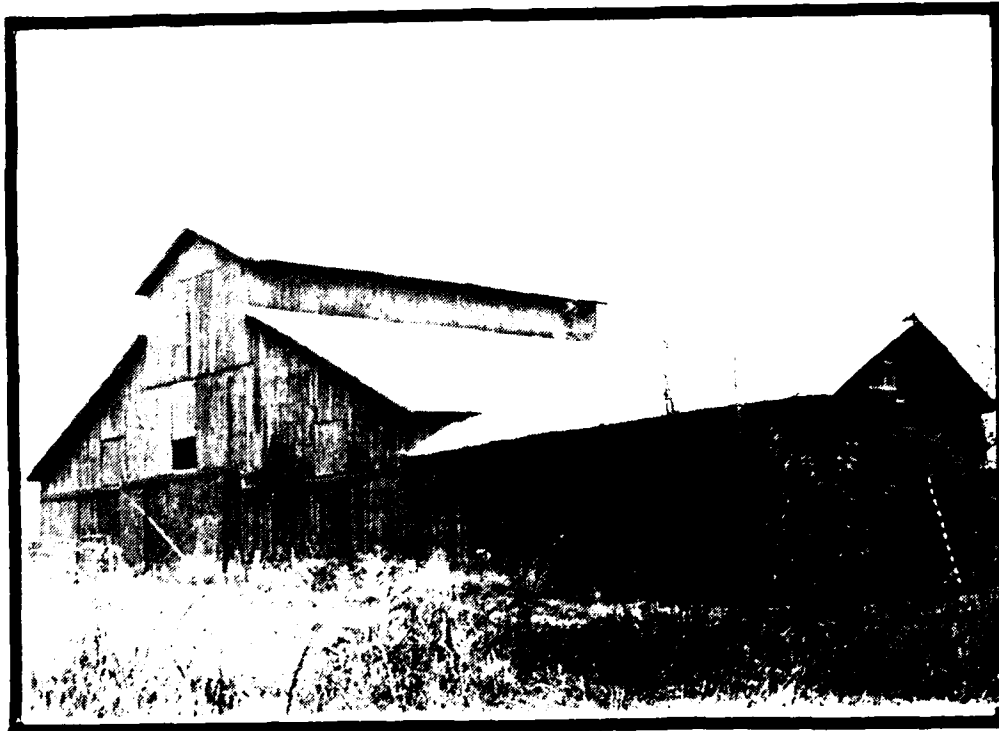
Figure 20. West elevation of barn at FN8 looking northeast. Monitor barn showing the rectangular extension of the southeast corner.

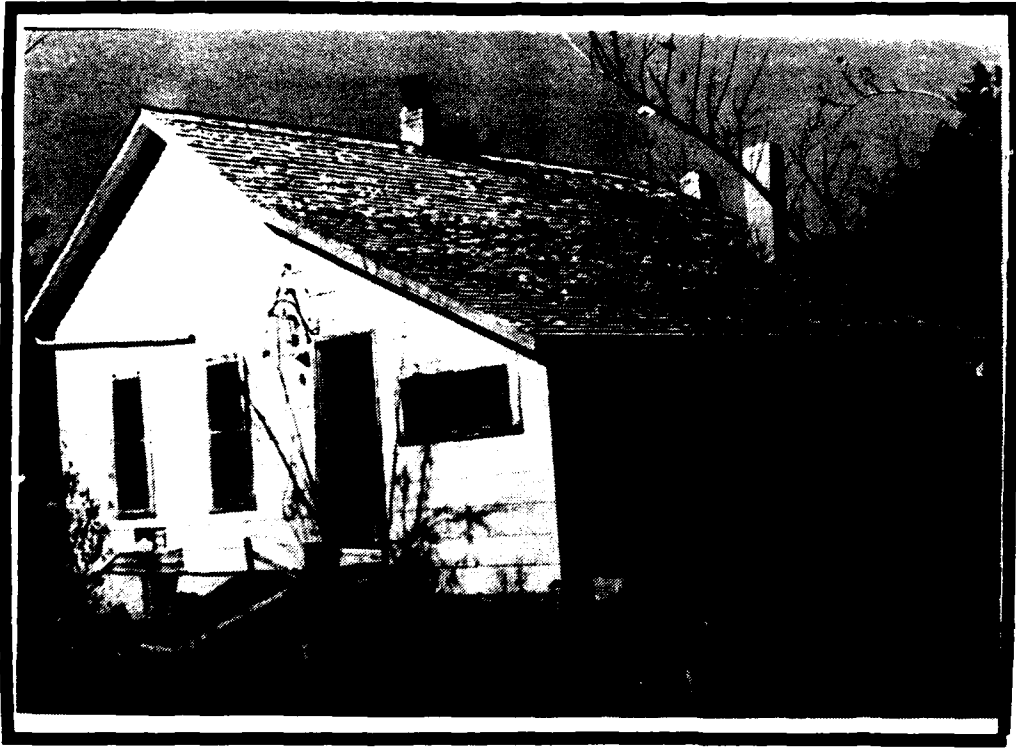
Figure 21. South elevation of house at FN9 looking northwest. One-story farmhouse with original wood shingles and asbestos siding.

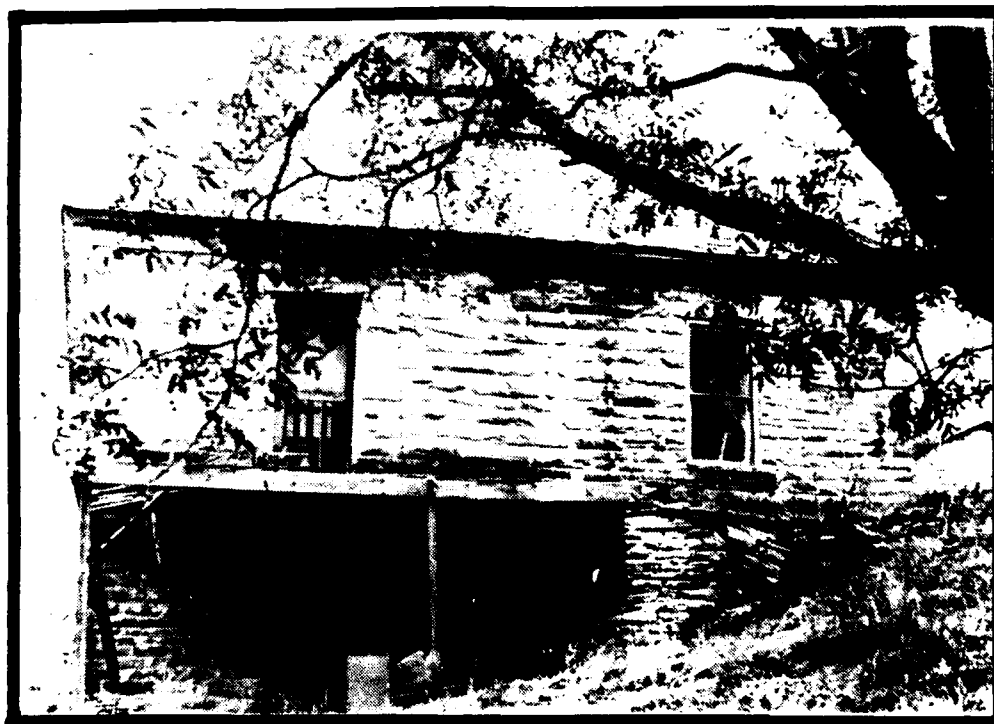
Figure 24. East elevation of house at FN10 looking west northwest. Remains of porch on east side.

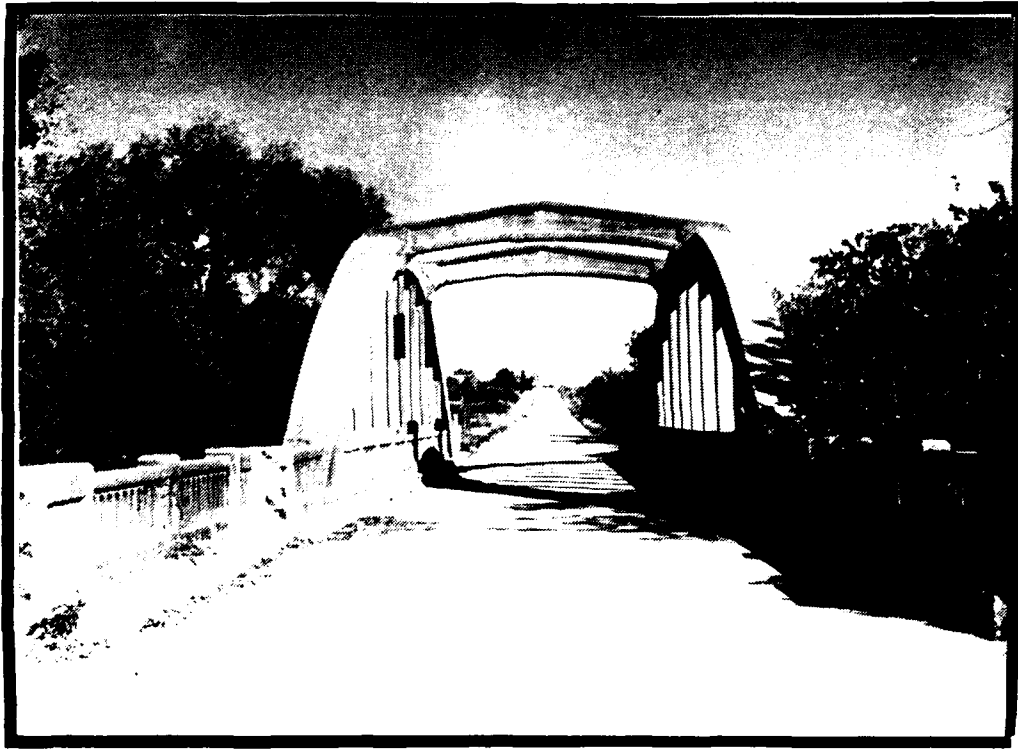
Figure 54. Concrete bridge, FN33, looking west.

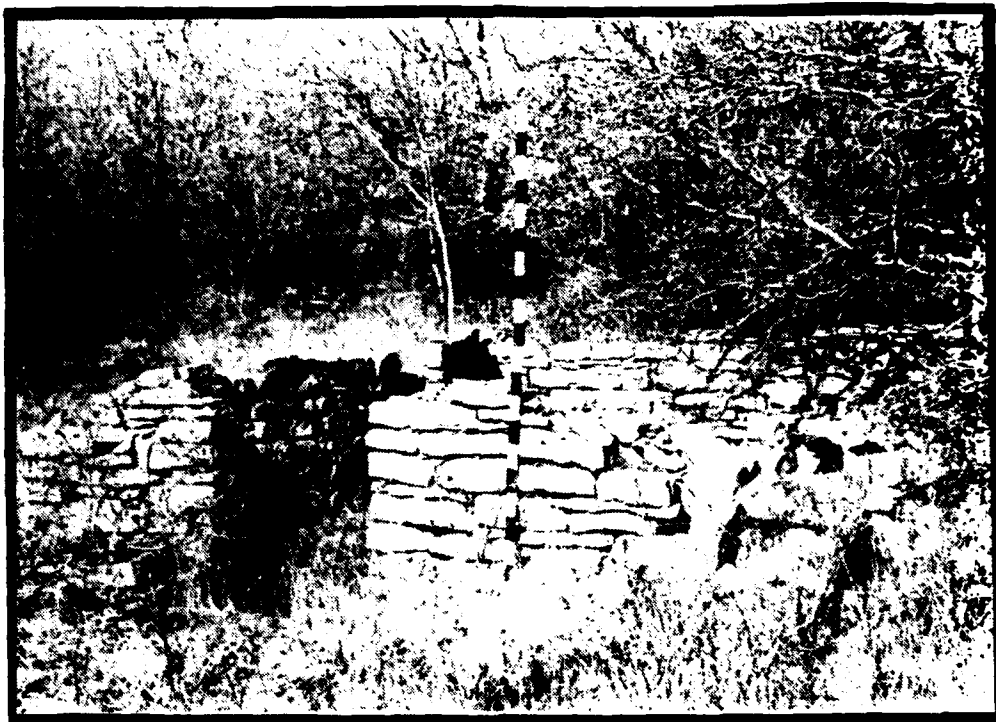
Figure 75. South elevation of building at FN66 looking north. Ruins of rock-constructed structure.

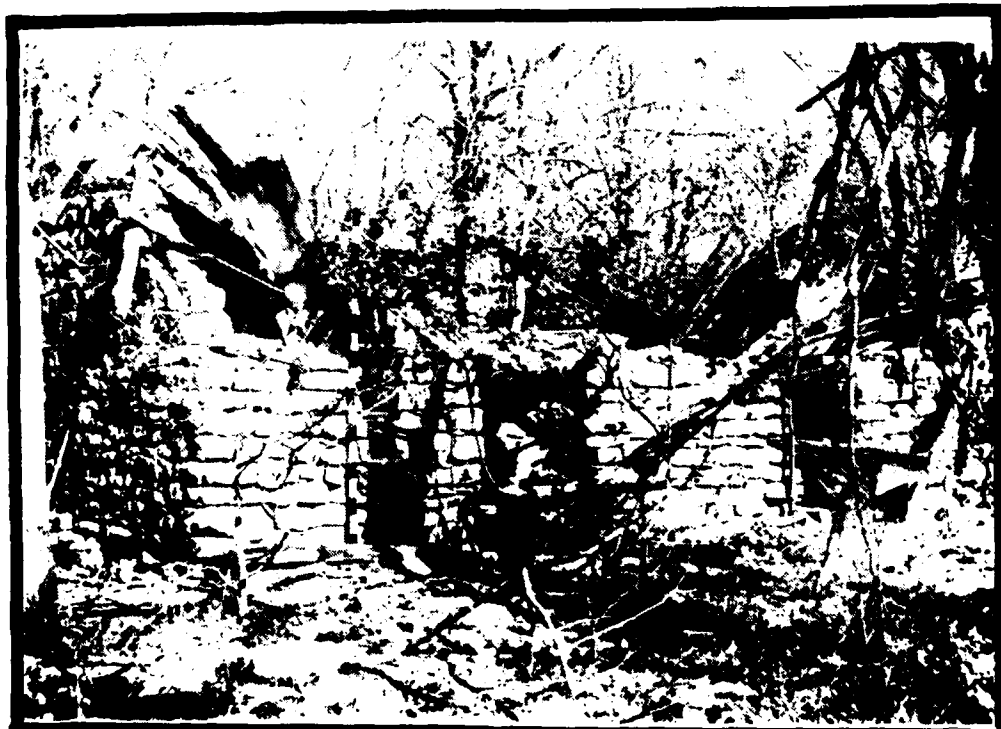
Figure 76. South elevation of house at FN66 looking north. Deteriorated stone house.
